Red Dog Mine and Fort Knox Mine Fish and Aquatic Bio- monitoring

Bill Morris, Alaska Department of Fish and Game,
Division of Habitat

Fort Knox Bio-monitoring

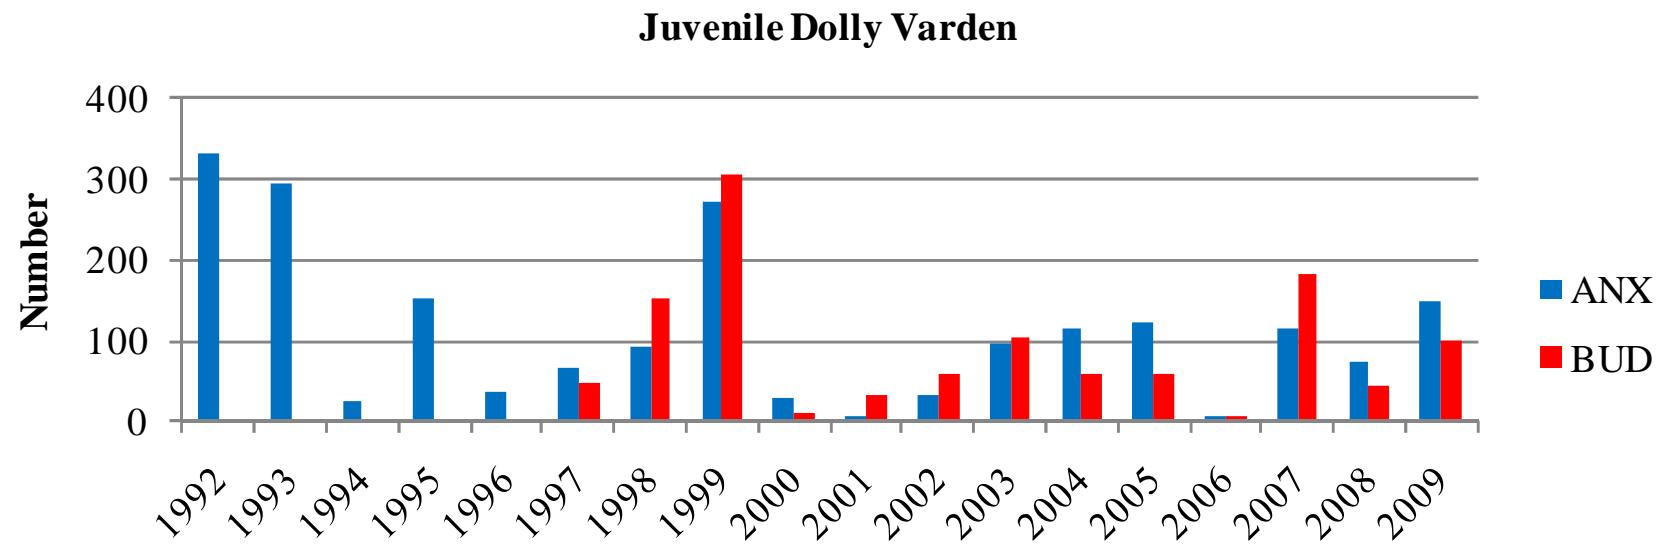
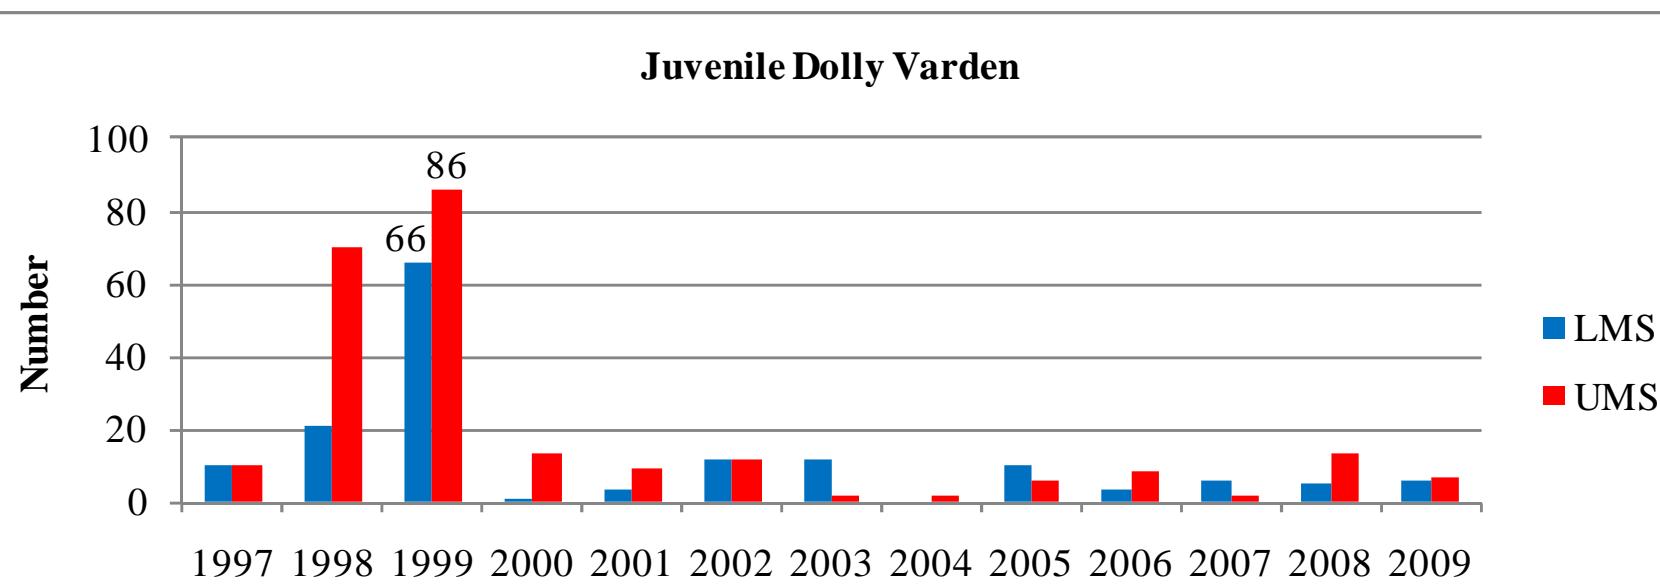
Tissue Sampling

Bons/Buddy Summary

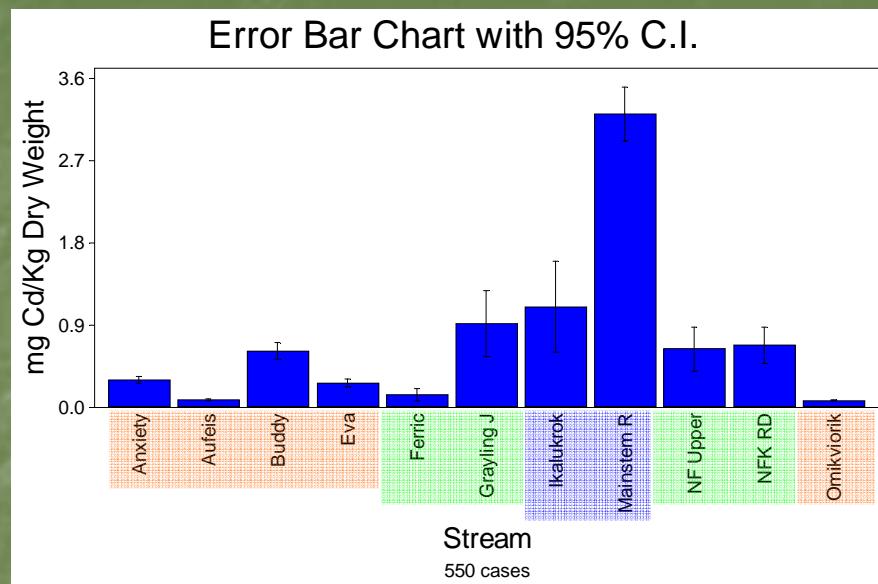
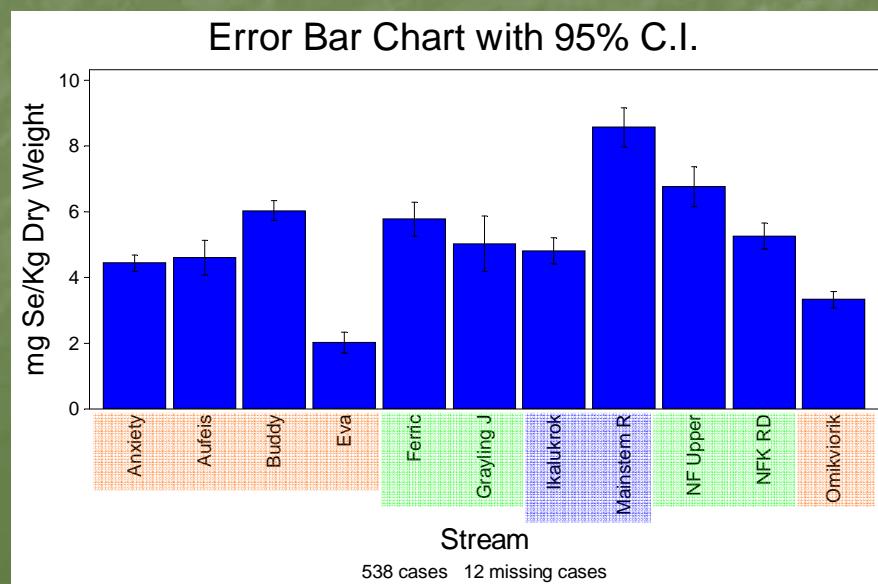
Multi-Site Comparisons

Road Sites

Natural Sites

Mine Effluent and Natural

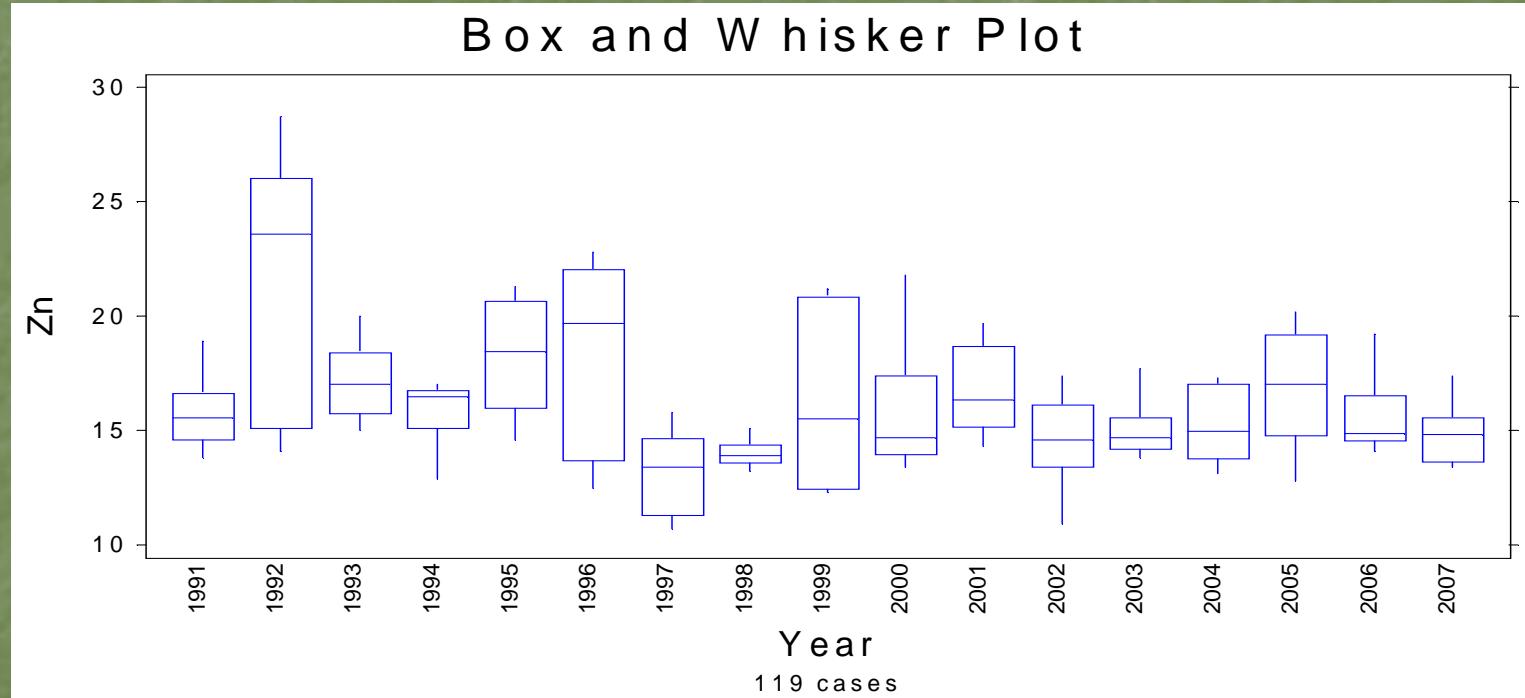
Long Term Data Adult Dolly Varden – Wulik River

Spring - Mg Zn/Kg Muscle Tissue

- Variations in metals concentrations in water and fish appear largely related to severity and temporal occurrence of natural seeps – road effects have been seen and corrected
- Long term trends do not suggest appreciable increases in metals or decreases in productivity

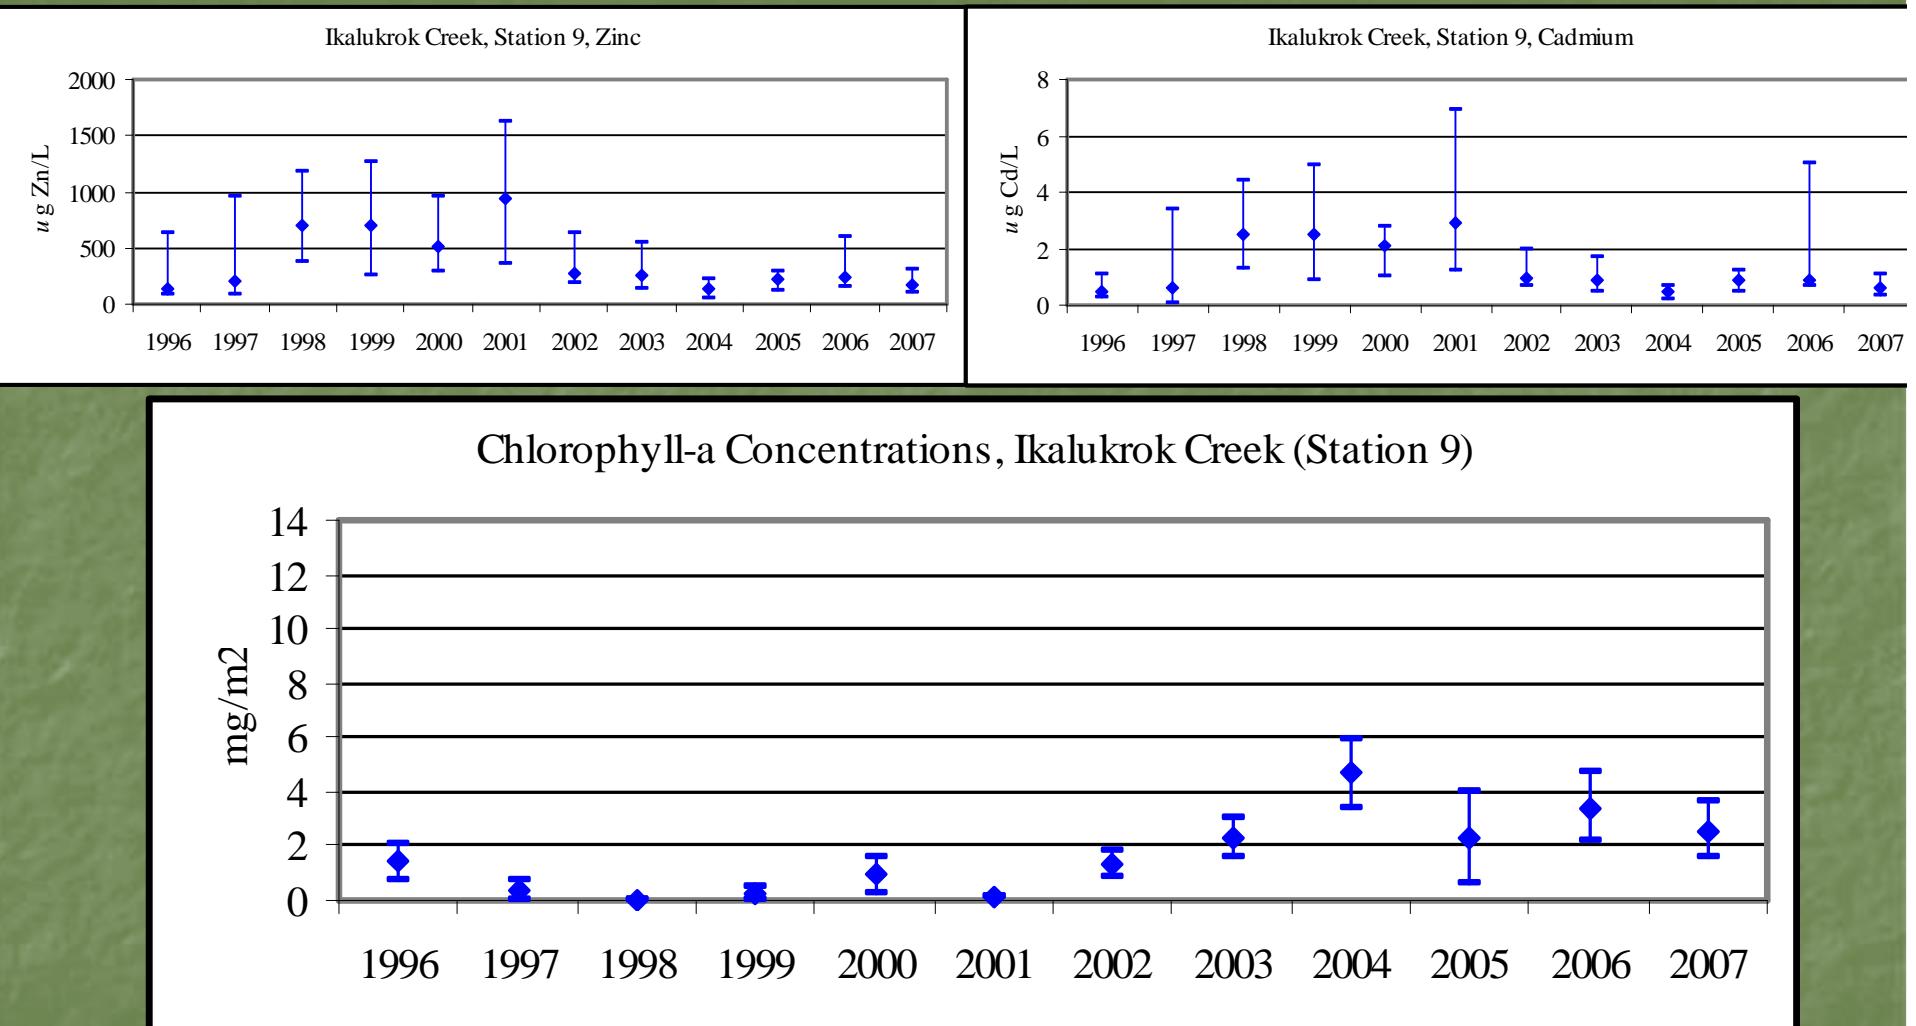
Long Term Data

Upper Ikalukrok Creek

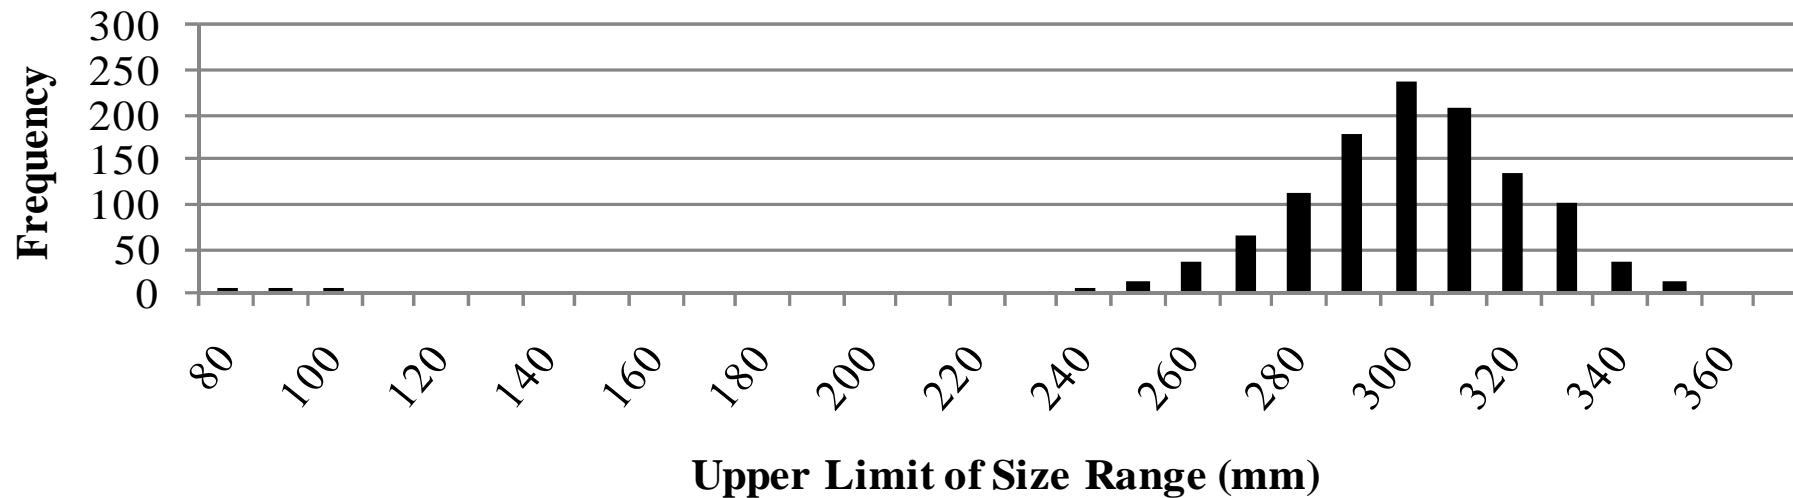
Arctic Grayling, Spring 2009 (n = 1,182)

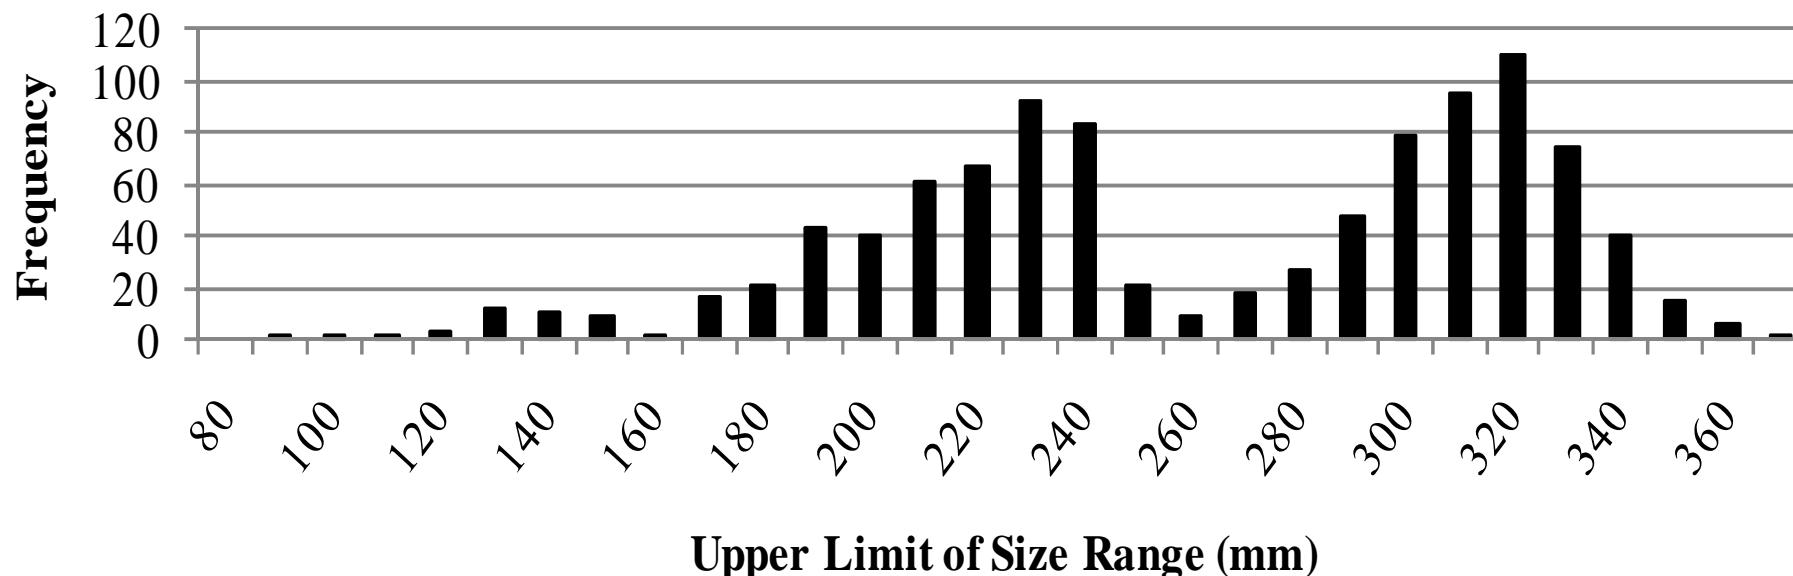
Arctic Grayling, Spring 2010 (n = 1,016)
